Windstorm Mitigation Affidavit Report

Marilyn Pines Unit I Condominium
Bldg A, 2060 Marilyn St, Units 101-116, 201-216
Clearwater, FL 33765

Prepared Exclusively for Marilyn Pines Unit I Condominium Association, Inc.

As of 09-18-2026 | FPAT File# MUD2627719

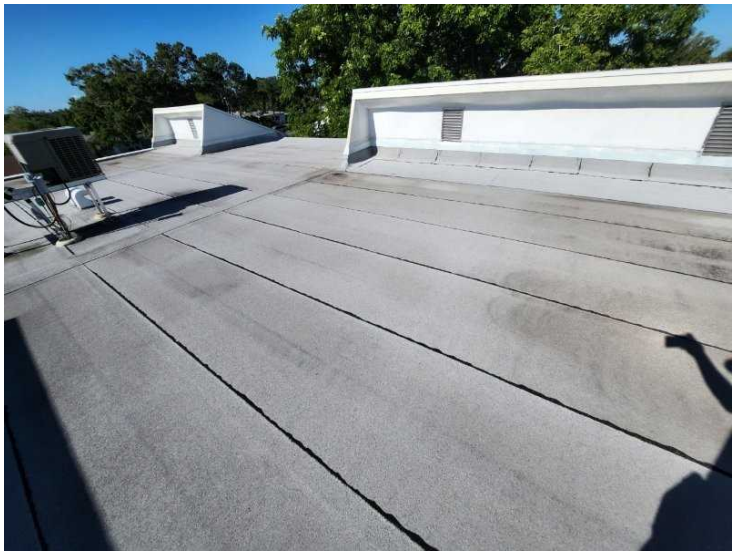
Roof Construction

5.	**Roof Deck Attachment:**	**C. 182 psf**
	Comments:	Inspection verified 1/2" plywood roof deck attached with 8d nails at a minimum 6" on the edge & 6" in the field.

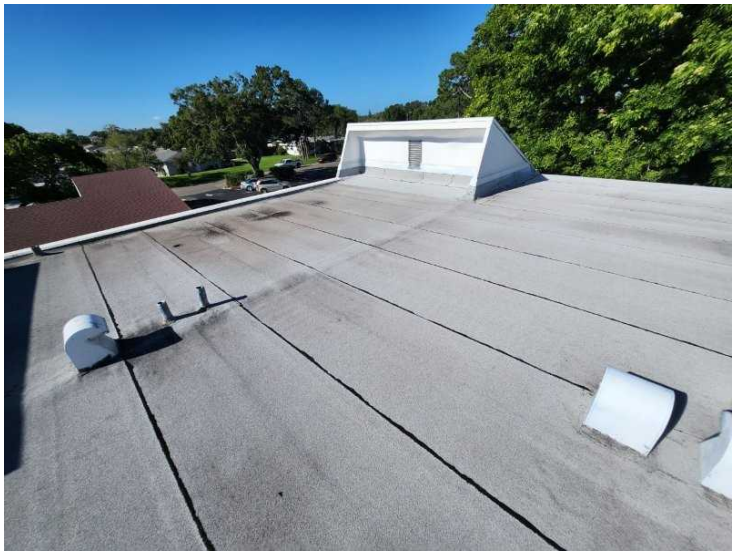
Roof Construction

6.	**Roof to Wall Attachment:**	**A. Toe Nails**
	Comments:	Inspection verified hurricane clips fastened with less than three nails.
7.	**Roof Geometry:**	**C. Other Roof**
	Comments:	The roof shape is made up of a combination of flat and pitched sections. The flat area of the roof comprises approximately 75% of the total roof area.

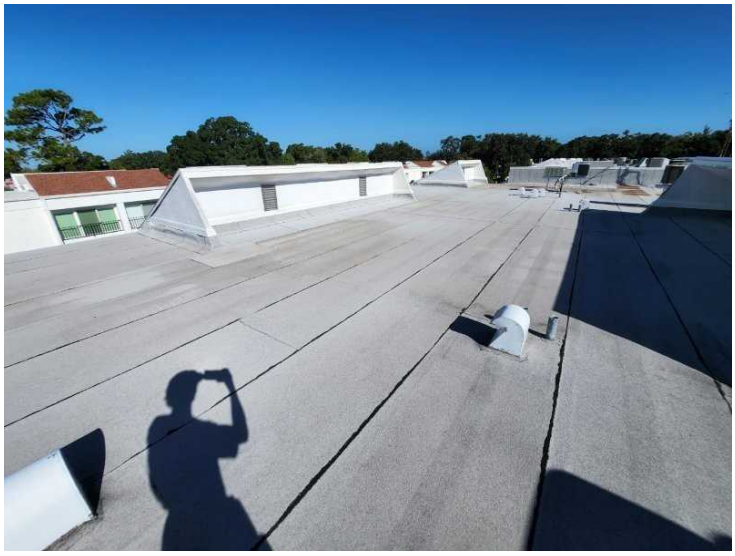
Roof Construction

8.	**Sealed Roof Deck/SWR:**	**B. No Sealed Roof Deck**
	Comments:	No SWR verified.
9.	**Opening Protection:**	**X. None or Some Glazed Openings**
	Comments:	No opening protection verified at the time of inspection.
